# ABRASION PROTECTION FOR SLUDGE SCREW CONVEYOR

ID: 8844

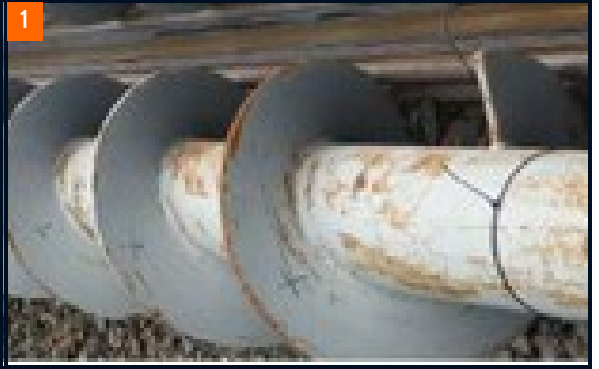
The bare steel had a short life expectancy in service. The sludge being transported by this screw was not only highly abrasive but also corrosive - these corrosive conditions would shorten the life of many abrasion resistant metal overlays.

A screw conveyor transporting waste sludge was suffering from abrasion & corrosion in service. A new screw conveyor was fabricated - heavy abrasion & corrosion resistance were required to extend its service life.

- 1 - Screw conveyor before
- 2 - Screw during application
- 3 - Belzona 1812 close up
- 4 - Belzona 1812 close up

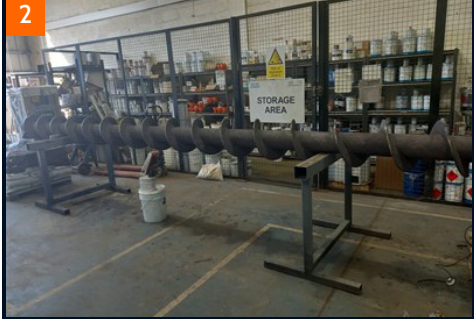
The screw conveyor was first grit blasted to SA 2.5 cleanliness & 75 microns profile. The Belzona 1812 (Ceramic Carbide FP) was then built up on the drive flights & the shaft body.

This was applied in accordance with Belzona system leaflet SHM-14.
