# BELZONA COATED SHIP SCRUBBER PIPES REVISITED AFTER TWO YEARS IN SERVICE

ID: 8845

RO – RO SHIP, TURKEY

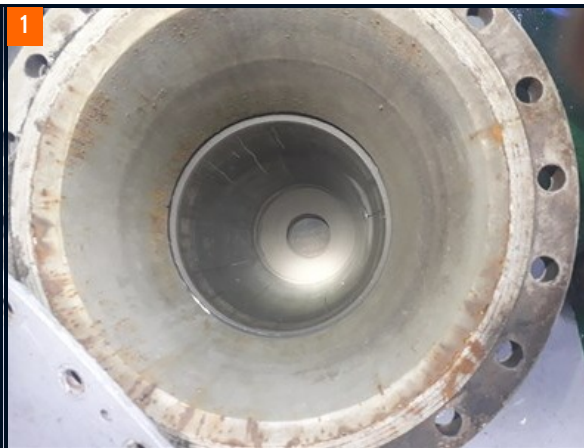
The corrosive and harsh environment of Exhaust Scrubber line fluid caused damage on internal steel pipe surfaces.

1. Scrubber pipe without any protective coating
2. After applied first coat of Belzona 1391T
3. After applied second coat of Belzona 1391T
4. Checked the condition of the pipes after 2 years of service

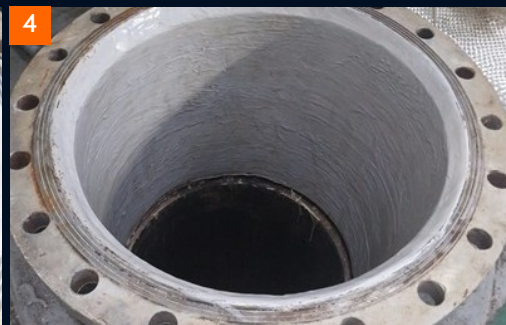
In the corrosive environment of exhaust scrubber lines, Belzona coatings offer protection against corrosion/erosion. The danger of damage and perforation on steel transition pipes was eliminated.
