# BELZONA PROTECTS BRINE PUMP BOWLS

ID: 885

Hydrocarbon Fractionation Facility /  
Hutchinson, KS

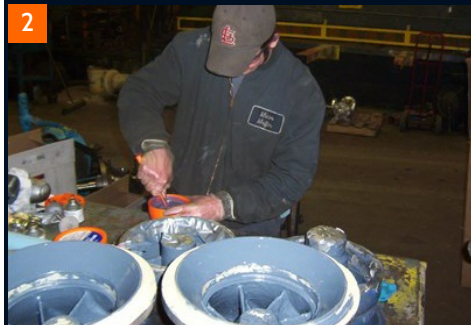
1. Grit blasted bowl with surface profile sample
2. Mixing Belzona 1321
3. Application under supervision in progress
4. Pump bowls with Belzona 1321 applied
