# CORRODED VESSEL REPAIRED WITH BELZONA SUPERWRAP II

ID: 8852

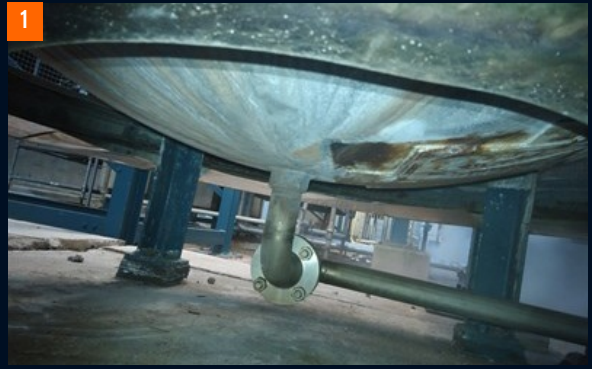
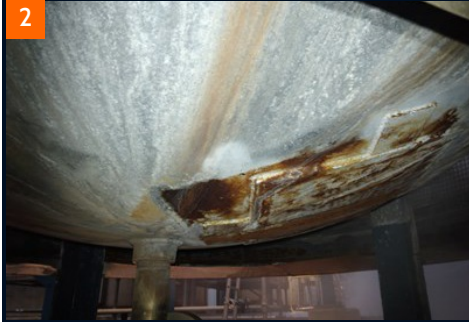
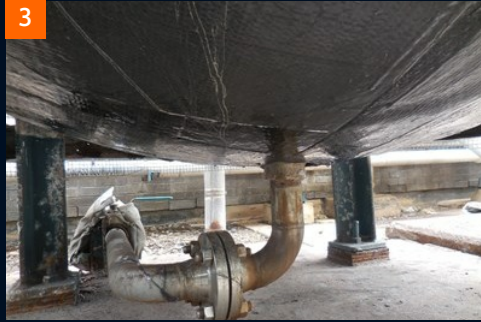
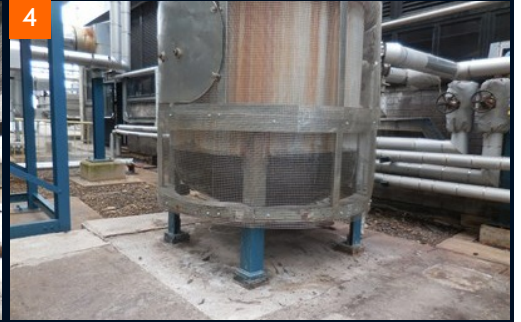
Welding had been attempted but had failed, leaks reappeared around the welded seams of the doubler plates that had been installed.

A vessel containing steam & condensate had developed several leaks due to corrosion on the bottom dome.

The vessel was grit blasted to achieve a surface profile. The welded plates were then skimmed with Belzona 1511 & any corroded areas filled. Following this four layers of Belzona Superwrap 2 were applied as a patch repair system across the full bottom dome of the vessel. Belzona 9382, mixing boards & ratchet straps were used together to consolidate the repair.

The Belzona repair was carried out over three days saving much downtime for the plant. This system avoided introducing further heat into the already weakened metal. The full encapsulation of the bottom dome ensures even if further leaks develop in the metal they will be contained by the Belzona system.
