# BELZONA 1593 PROVEN TO PROVIDE LONG TERM PROTECTION IN MOLTEN SULPHUR

ID: 8856

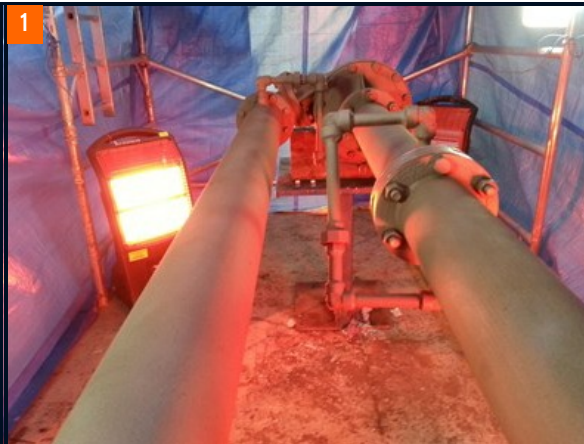
1. Pipes grit blasted ready for application of Belzona coating
2. Pipes coated with Belzona 1593
3. Pipes coated with Belzona 1593
4. Pipes revisited 5 years later showing minimal damage to the coating

The surface to be coated was grit blasted to a surface cleanliness of Sa2½. Belzona 1593 was then applied in two coats to provide outstanding corrosion protection. The application was carried out in accordance with Belzona Know-How System Leaflets VPF-2.

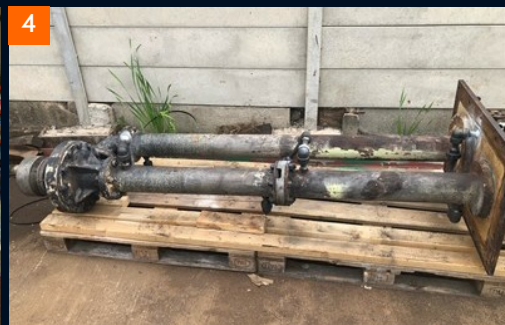
Since 1997, Belzona 1591 has been used to coat many of the pumps in a sulphur pit. When this product was replaced by Belzona 1593, the client was keen to utilise this improved solution however there was minimal testing available in this type of situation. This pump was originally coated in 2017, when the pumps were revisited in 2022, there was little damage to the coating. The client chose to fully recoat the pipes even though a small repair would have been sufficient.
