# BELZONA PREVENTS PROLONGED SHUTDOWN DUE TO SULFURIC ACID FLANGE LEAK

ID: 8857

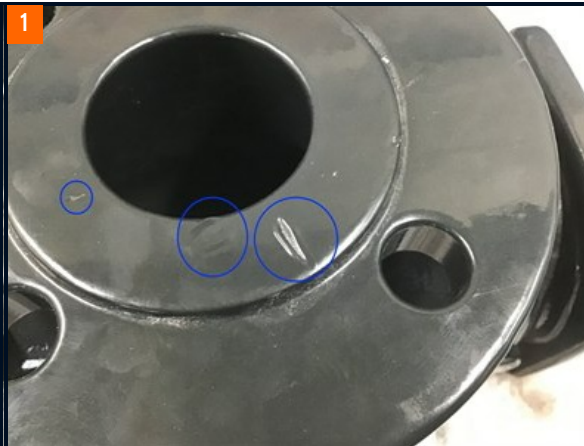
The client had an emergency shut down due to hot sulphuric acid leaking from a flange which had previously been coated with a fluoropolymer. The job was very small but was enough to shut the plant down as the existing coating had failed causing a serious and dangerous leak.

Damaged flange in a suction chamber.

1. Areas of concern
2. Close-up of the fluoropolymer coating
3. Belzona 1392 repair

The flange was taken out of service and taken to the Belzona workshop in Wrexham for repair. The applications team prepared the defective areas using mechanical tools to make the surface as rough as possible, angle out the grooves and get down to steel where possible. The surface was also cleaned and degreased prior to the application of a thick coat of Belzona 1392. The product was applied level with the remainder of the flange face to ensure the gasket sat tightly on the surface. Once the product had cured, the component was transported back to the customer's facility.
