# BELZONA EXTENDS CHILLER LIFE

ID: 886

Museum, Kansas, USA

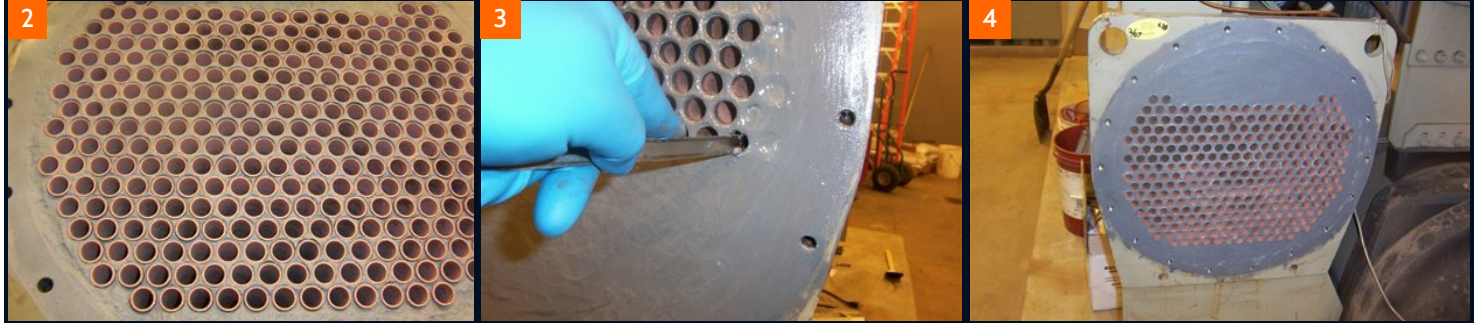
Corrosion threatened the life of the chiller. With tight budgets the loss of a chiller would be unacceptable.

1. Tube sheet before blast cleaning.
2. Grit blasted tubesheet. Damage is very evident.
3. Excess material removed from tube with the smooth side of hacksaw blade.
4. Tube sheet ready for years of trouble free service.

Application was carried out in accordance with Belzona Know-How System Leaflet HEX-1 and HEX-3.

Belzona 1311 (Ceramic R-Metal)  
Belzona 1321 (Ceramic S-Metal)
