# BELZONA SUPERWRAP II RESTORES STRENGTH TO 26 METRE SEWAGE PIPELINE

A 26-metre pipeline which was leaking sewage into a farmer's field causing environmental pollution.

Water Authority, Scotland

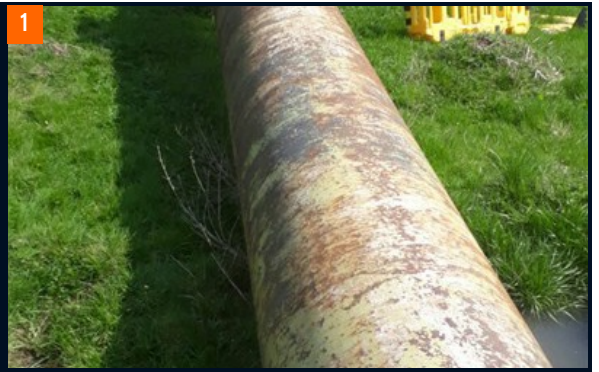
The heavily corroded, 900mm diameter pipe is the main sewage line for a nearby town and if the issue was not rectified, there would be a huge cost for the asset owner. Pipe replacement was not an option due to complications in isolating this section. As this type of overland pipe is exposed to the elements, it often corrodes more than buried sections.

1. Corroded sewage pipe
2. Plate bonded in place
3. Completed wrap, Release film in place, Fabricated box
4. Pipe back in service with Belzona SuperWrap II completed

Firstly, the area was cleaned, and the pipe surface was grit blasted to the required standard. The live leaks were repaired by bonding prefabricated Belzona SuperWrap II plates over the leaking areas using Belzona 1121 (Super XL-Metal). Next, to provide complete protection, three layers of Belzona Superwrap II were mixed and applied to the external surface of the pipe. Once the pipe wraps had been applied, Belzona 9382 release film was applied around the wrap system and allowed to cure overnight.
