# BELZONA SEALS BRIDGE LEAKS

ID: 8863

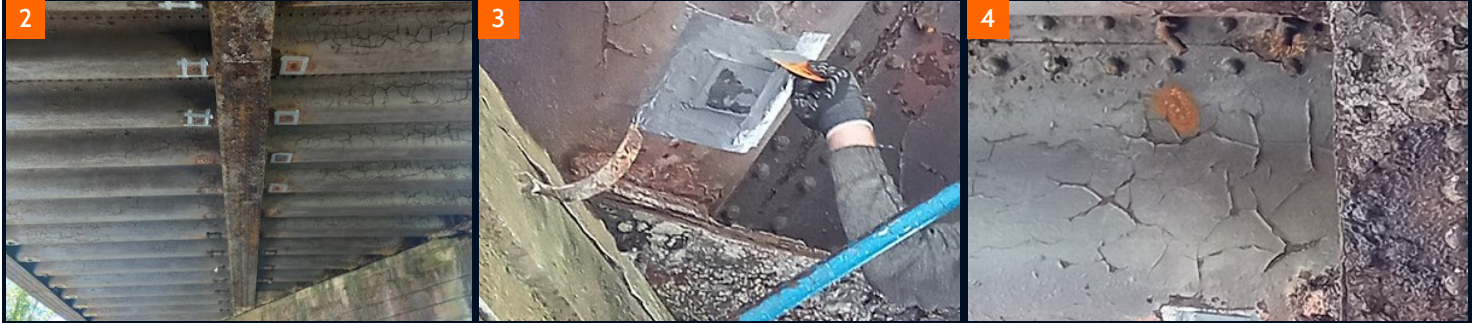
## PHOTOS

Welding had been attempted but was found to be time consuming and impractical on the area. Any water present behind the gaps during the welding process would pose a hazard to the technician.

A bridge had several gaps where water could penetrate & drip down onto a waterway below. A solution was required to seal these leak points.

1. Bridge with leaking sections
2. Areas marked out
3. Belzona 1121 plate bonding
4. Application 18 months later

The gaps were first marked out & prepared with an angle grinder. Suitably sized plates were sourced & prepared in the same way. The plates were then bonded to the surface. The slump resistance of the Belzona material was sufficient to hold the plates in place with no additional shuttering, saving time & cost.

Belzona 1121 was used due to its extended working life, this feature was beneficial on this application as the works were carried out from a MEWP & time was needed to position in between the plate applications. The application was reviewed 18 months later and is in perfect condition
