# BREWERY WASTER BEER SETTLING TANK LEAK REPAIR

ID: 8864

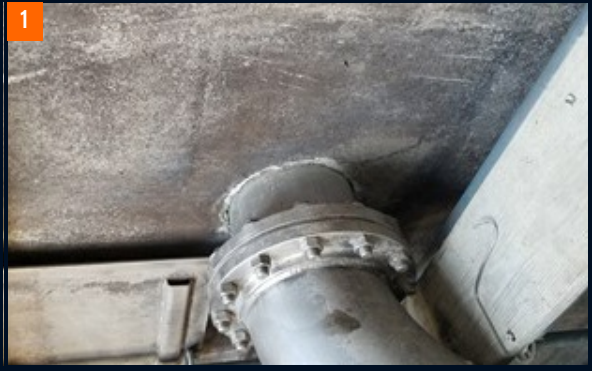
Gap in concrete tank has silicone filler leaking around the stainless-steel fill pipe into the adjoining tank.

Beer wastewater was leaking through the concrete and steel pipe gape into another adjoining tank.

1. Before application (far angle).
2. Before application (close angle).
3. Finished application (close angle).
4. Finished application (far angle).

The first step was using hand tools much like a grinder with grinding disk and/or a pocketknife to clean the substrates. Then, B-1212 was applied to fill the small void between the concrete tank and stainless-steel pipe by pressing in the paste grade with a Belzona applicator. Following that, a chamfer was created around the 12" Diameter pipe and concrete gap by spreading it up the concrete wall 2" all the way around the pipe and out towards the flange a couple inches. Then, an additional B-1111 paste grade was added to build more material on top of B-1212 to create a thicker substrate along the pipe and to ensure the area is sealed. For added insurance and to give a good chemical resistance since B-1321 S metal is also an approved AB – Budweiser product to come into beer contact (even though this is a waste tank) we topped it off in 2 x coats of 1321 S metal to completely seal the paste grade for a stouter permanent repair.
