# BELZONA SEALS THE BASE OF STORAGE TANK

ID: 8865

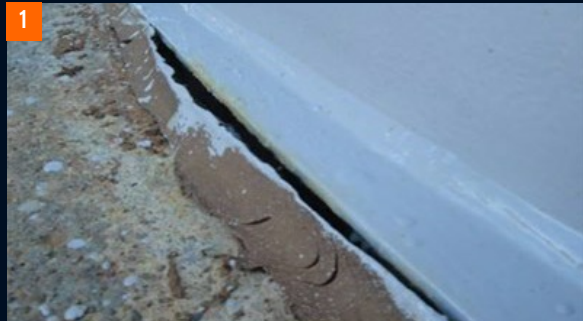
A large diameter storage tank had a mastic seal installed between its annular rim & concrete base. This mastic had become disbonded due to its lack of flexibility. A solution was required to seal this gap to prevent corrosion whilst maintaining flexibility.

1. Original mastic failure
2. Close up of application
3. Completed application
4. Completed application
