# BELZONA SEALS CONDENSER EXPANSION JOINT

The #4 generator condenser expansion joint.

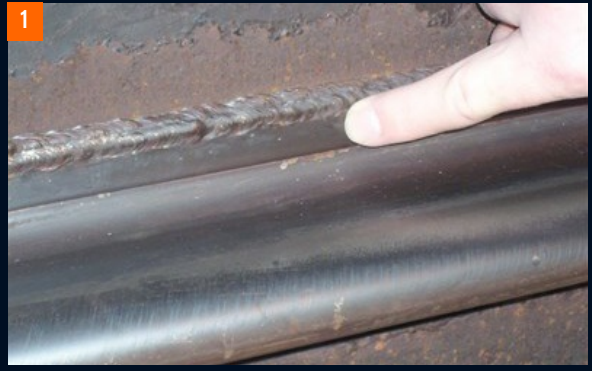
The efficiency of the unit was low because of the leaks in the expansion joint.

1. Leaking expansion joint
2. Mixing Elastomer
3. First coat
4. Second & Third coat

Application was carried out in accordance with Belzona Know-How System Leaflet HEX-5. The surface was prepared with a vacublast unit. After Conditioning, three coats of Elastomer were applied to the expansion joint and approximately one inch beyond the joint.
