# OIL REFINERY ADOPTS BELZONA COMPOSITE PAD FOR PIPELINE REPAIR

ID: 8870

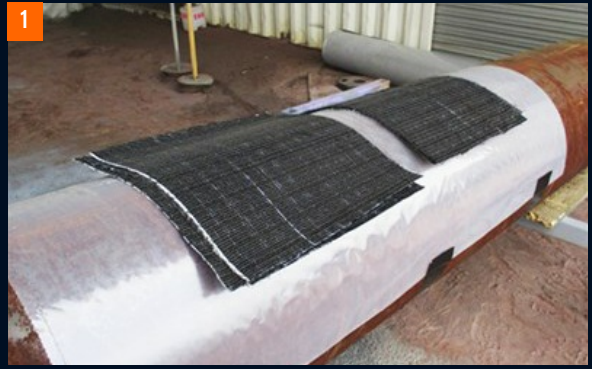
1. Reinforcement Sheets Cut to Required Size
2. Wetting out Reinforcement Sheets
3. Reinforcement Sheets Applied to Pipe Contour
4. Belzona Composite Pad Bonded to the Pipeline

A Belzona SuperWrap II Composite Pad was fabricated to the exact dimensions of the pipe, on-site by qualified SuperWrap II Contractors. The cured Composite Pad was then bonded in place using Belzona 1111 (Super Metal). Due to its lightweight nature, the application could be applied by just two technicians. The application was carried out with a modified version of Belzona System Leaflet VPF 15.
