# BELZONA REFURBISHES A HEAT EXCHANGER IN THE SUGAR INDUSTRY

ID: 8873

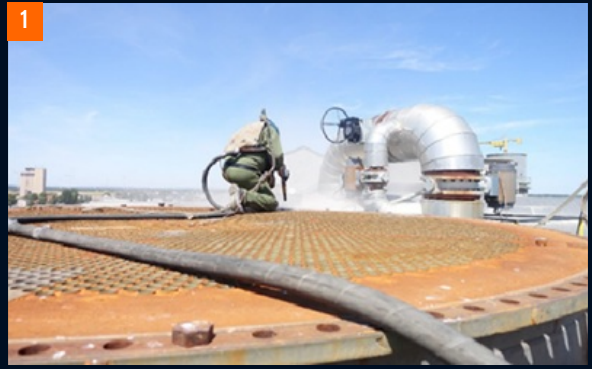
1: Blasting Surface

The plate was blasted in accordance with the Belzona IFU. The plate was washed twice with Saltaway + deionized water + blown dry. The application was carried out in accordance with Belzona System Leaflet HEX-1 and HEX-3.

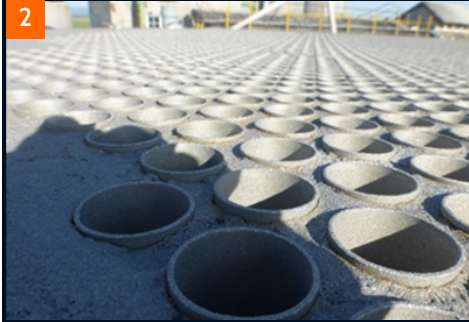
2: Surface after Blasting

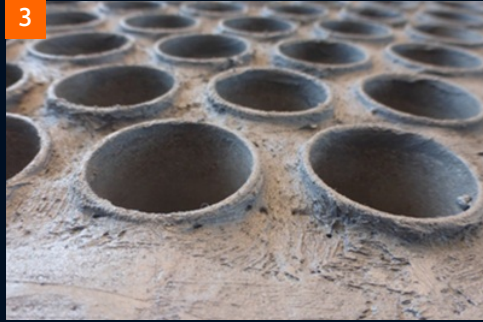
3: Application of Belzona 1511

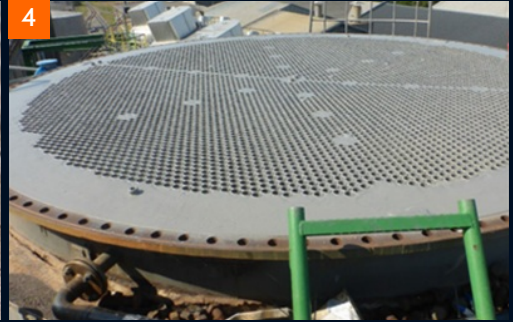
4: Completed application with Belzona 1391S
