# BELZONA RESTORES A PUMP IMPELLOR

ID: 8874

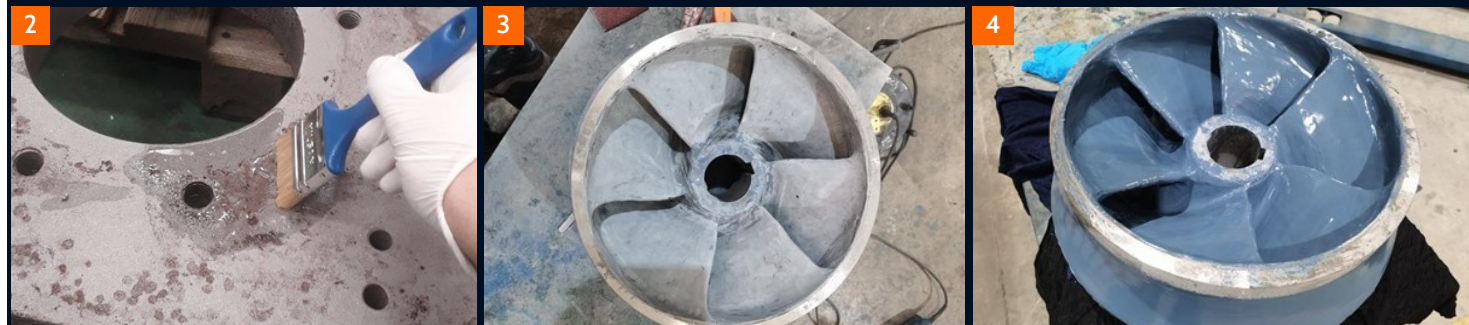
The impeller had suffered from significant erosion corrosion damage, leading to the need to replace.

Belzona was able to renew this heavily worn and corroded pump impeller, extending its life span further - saving it from the scrap heap!

Application was carried out in accordance to Belzona system leaflet CEP-01. The impeller was first blasted to achieve a min 75 micron profile and SA2.5 finish prior to the rebuilding. It was then balanced before being returned to service.
