# BELZONA WEATHERPROOFS INSTRUMENTATION CONTROL ROOF

ID: 8875

Building roof (240m<sup>2</sup>) of an Instrumentation & Control office within a Petrochemical Depot.

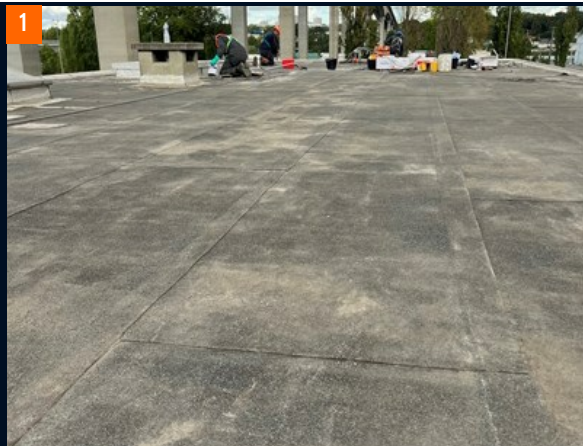
- 1). Roof after the gravel was removed.
- 2). Close-up of area where roofing felt had to be removed due to rot.
- 3). Post-application of Belzona Stripe Coating on all edges and entry-points around the skylight.
- 4). Finished application with 2x coats of Belzona 3111 and Reinforcement Sheet.
