# BELZONA SUPER WRAP II ON HIGH PRESSURE PIPE OFFSHORE

ID: 8878

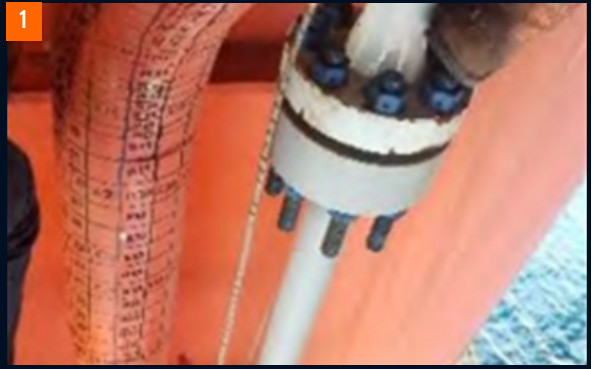
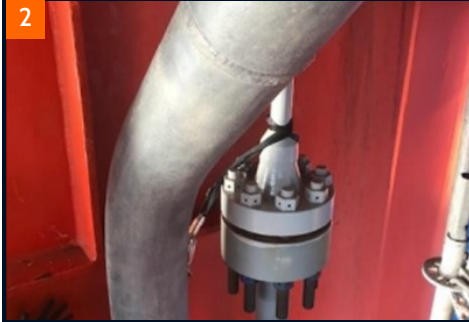
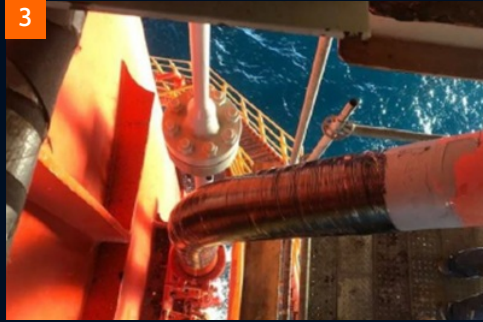
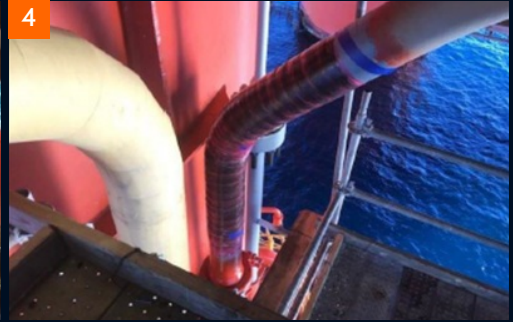
The pipe is a very important part of oil & gas operations for this customer. The application area was difficult to access. External corrosion created thinning of the wall thickness on the pipe causing a solution to be found to protect this pipe.

An 8in diameter liquid hydrocarbon line of a major Oil & Gas Owner on an offshore platform in the Gulf of Mexico experienced external corrosion. UTS was performed to determine the wall thickness of the pipe. The MAWP of the line is 5000psi. The application area was reached via Rope Access. SuperWrap II was chosen as a preventative measure to protect the pipe. Replacement costs are not feasible at this time and a shut in would require a major loss in cash flow.

1. Power tool prep via MBX Bristle Blaster to bare metal (SSPC-SP11). Wipe the surface clean with Belzona 9111 and let dry.
2. Belzona 1161 was applied to the thin wall areas.
3. Belzona SuperWrap II system was applied per the design at 3 wraps / 18in axial extent. Belzona 9382 was used to consolidate and allow to cure.
