# BELZONA SEALS POROUS TANK WELDS

ID: 888

Stainless steel herbicide tank

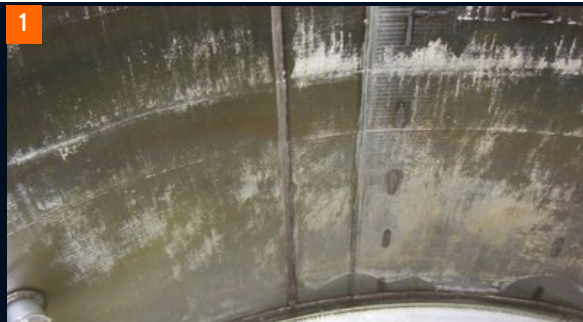
Porous welds in stainless steel tank. Herbicide is expensive and very slippery. Not only was leaking tank an environmental hazard but a general safety hazard as well.

1. Tank interior before application
2. Tank seams coated with Belzona 4301

Application carried out in accordance with Belzona System Leaflet TCC-1. The tank was drained and rinsed. A stainless steel tank cleaner was used to clean the surface.

Two coats of Belzona® 4301 were applied to the weld seams.
