# PROTECTION OF THE DISCHARGE PIPE AREA ON SHIP

ID: 8880

Protection of the surface of the discharge pipe DN600 and the surrounding shell plate of the hull

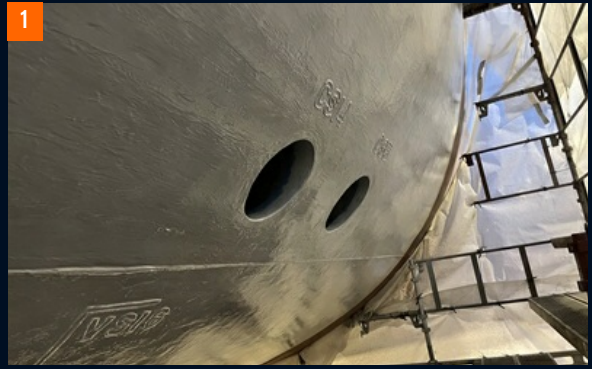
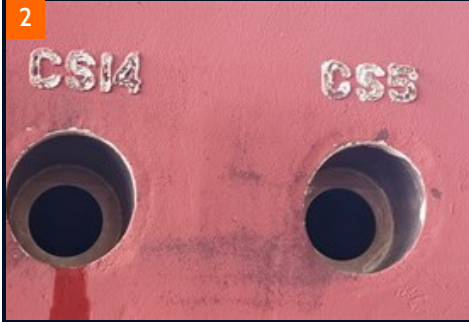
The original glass flake coat had broken after a few years in service. This leaves the ship unprotected and vulnerable to corrosion.

1. initial condition of ship
2. initial condition of ship
3. during application
4. application complete

The area was grit blasted, roughness was measured and the salt contamination determined (result ok)  
Two coats of 1391T were applied
