# AUTOCLAVE REPAIR USING BELZONA SUPERWRAP II

ID: 8881

## PROBLEM

Leaks on the weld seam of the water-cooled jacket of this process vessel.

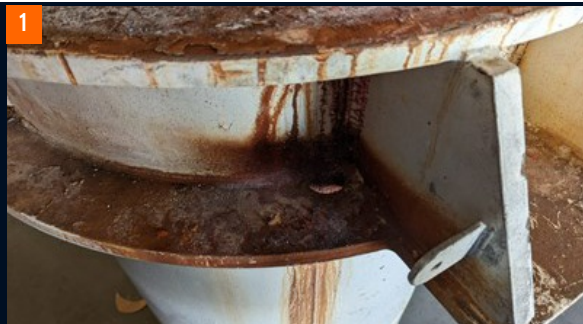
1. Initial condition
2. Plate bonding applied
3. Application of Belzona SuperWrap II
4. Complete application
