# EXTERNAL CORROSION PROTECTION FOR VALVE PARTS

ID: 8882

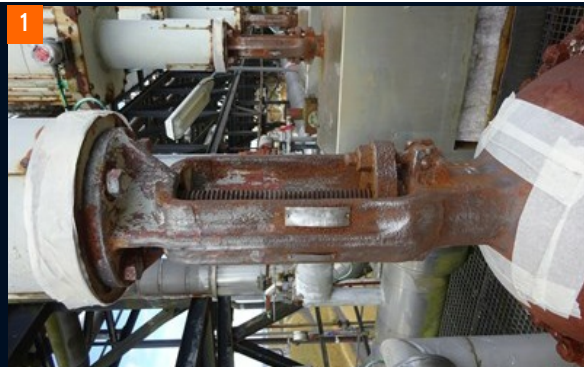
1. Area taped out
2. 1st coat of Belzona 3412 applied
3. Close up of application
4. Completed application

The exposed steel was first prepared to a ST-2 standard. Belzona 8411 was then applied followed by two coats of Belzona 3412
