# BELZONA REPAIRS & PROTECTS CONTROL VALVE

ID: 8889

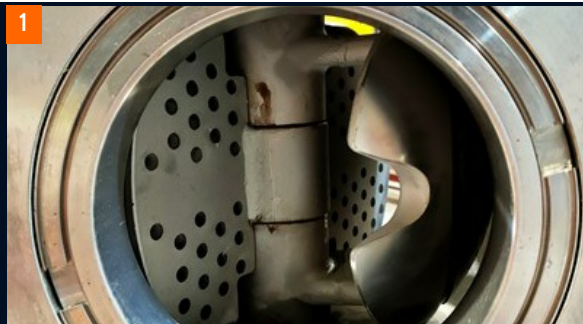
A stainless steel control valve had suffered from cavitation erosion in service. The erosion had gone through the wall in some areas of the valve body.

1. Valve showing internal parts
2. Close up of the cavitation damage
3. The damage rebuilt & the area coated with Belzona 1341 Supermetalgilde
4. Belzona 2141 ACR Fluid Elastomer applied

The valve was disassembled, the critical parts were protected with blasting tape & then the internal surface was prepared to SA2.5 & 75 microns.
