# BELZONA REPAIRS NEW HEAVY EQUIPMENT TIRE

ID: 889

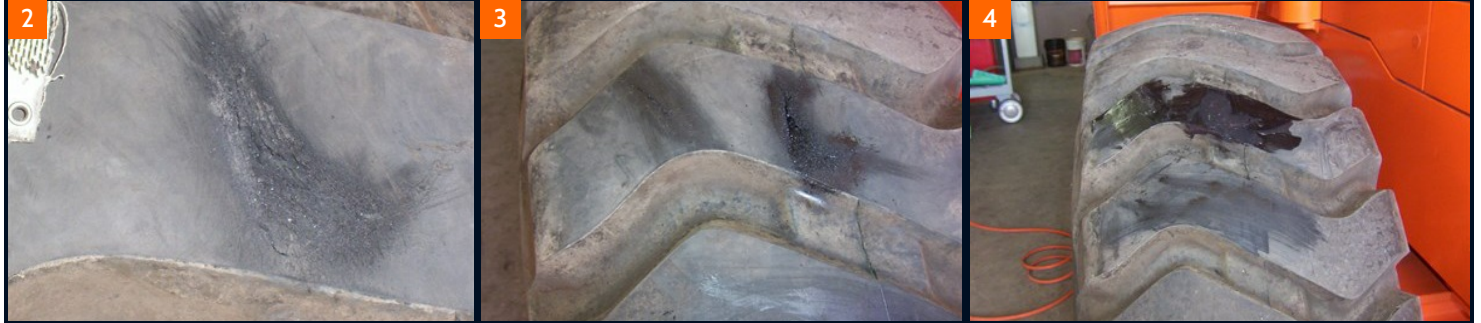
## PHOTOS

When the transport unloaded this brand new loader, the tire was damaged.

1. Damaged portion of the tire
2. Roughened surface
3. Surface conditioned
4. Tire rebuilt with Belzona 2311

The application was carried out in accordance with Belzona Know-How System Leaflet SHM-1. The surface was prepared with a roughing brush and conditioned with Belzona® 2911 (QD Conditioner). The gouges in the rubber tire cover were rebuilt with Belzona® 2311.
