# WASTEWATER PUMP IMPELLER

ID: 8912

Wastewater impeller was damaged and needed to be rebuilt and coated.

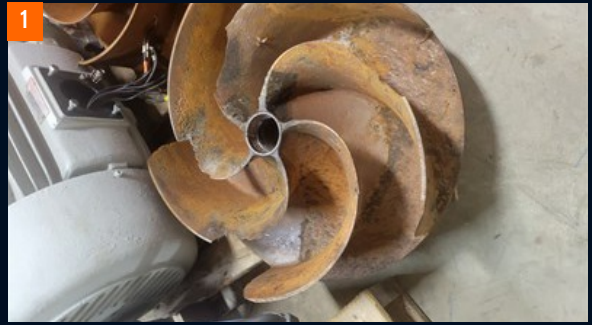
Pump Impeller was pitted and damaged, and missing chunks out of a few of the veins, and they were wore down on the ends. We needed to build up the veins and pitted areas, and then coat to protect the impeller from further damage in the future.

1. Damaged Impeller
2. Impeller after being blasted
3. Impeller built up with expanded metal
4. Impeller rebuilt with expanded metal, Belzona 1111 Supermetal, and coated with Belzona 1321 S-Metal.
