# BELZONA REPAIRS & PROTECTS PHOSPHORIC ACID BUND

ID: 8914

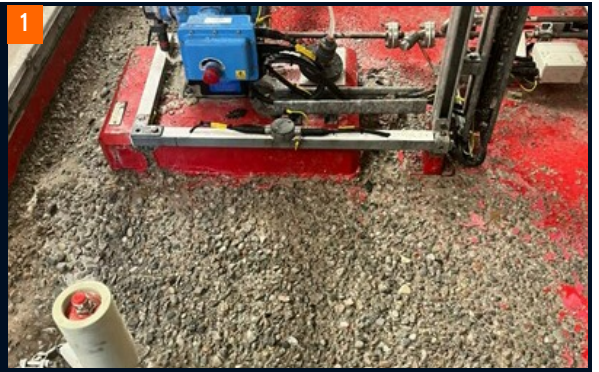
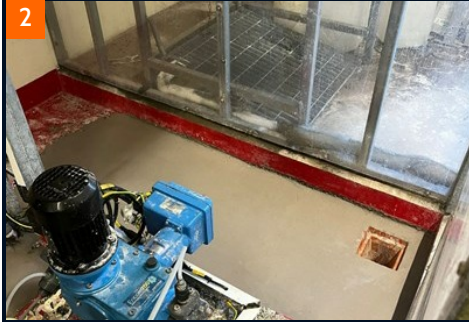
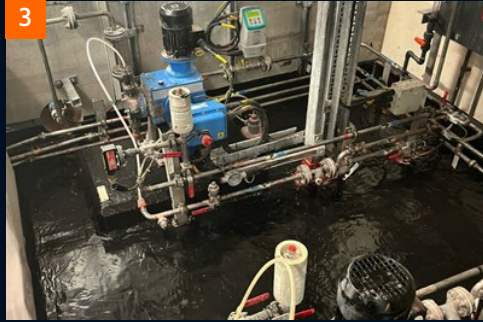
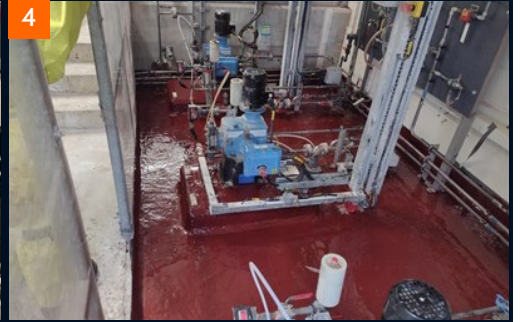
The previous coating within the bund had been corroded away leaving the underlying concrete susceptible to damage. A long term repair & protective solution was required.

A bund containing several pumps had become severely corroded due to Phosphoric acid leaks. Significant sections of concrete had been affected by the acid.

The bund was prepared using a high pressure wash. This removed the damaged sections of concrete & decontaminated the remaining concrete.

Belzona 4911 TX Conditioner was applied followed by Belzona 4131 Magma Screed to bring the corroded areas back up to the original floor level.

Two coats of Belzona 4341 CR4 were then applied for long term acid protection.
