# BELZONA SEALS LEAKS IN CLEAR WATER STORAGE TANK

ID: 8915

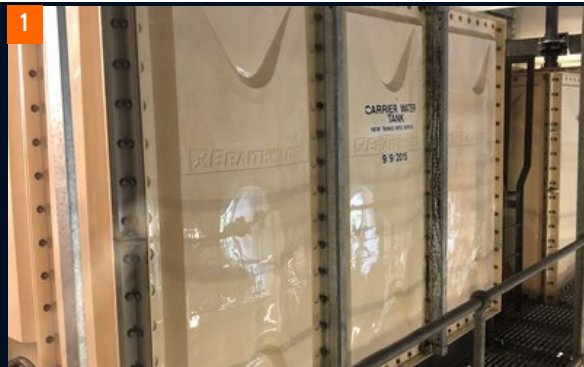
A clean water storage tank had developed several leaks from the sectional joints that hold the tank together.

1. Storage tanks
2. Belzona 1111 applied to fair the gaps between the tank sections
3. Belzona SuperWrap 2 system applied to the tank joints
4. Belzona 5811DW2 applied as a top coat
