# BELZONA PROTECTS A CONTAINMENT AREA

ID: 8922

The Hydropower plant required a protective coating for the transformer oil containment area. The coating should be able to withstand oil penetration in concrete in case of leaks from the transformers.

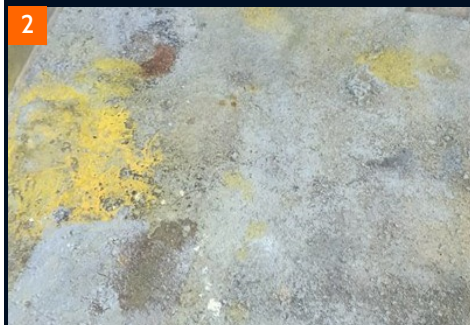
The floor had started to deteriorate due to oil and water ingress. The client analysed and tested several materials with no results. The physical and mechanical properties including adhesion testing of the Belzona provided the reassurance the client needed to select Belzona for protection and to ensure that coating would have the required longevity.

1. Pictures before application
2. Pictures before application
3. Containment Area after application
4. Accessing floor also coated

Application carried out in accordance with Belzona System Leaflet FPA-3.
