# BELZONA PROTECTS BRINE STORAGE AND SATURATOR TANKS

ID: 8928

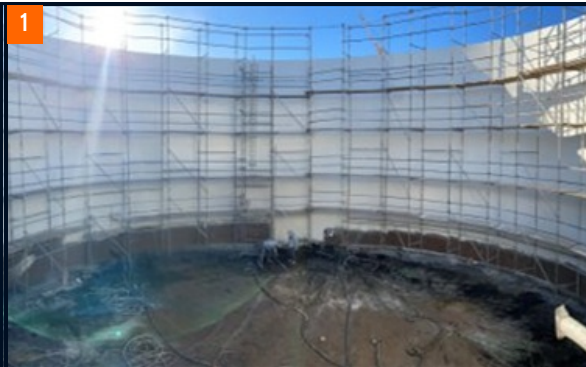
1. Area to be protected.
2. Surface preparation.
3. First coat being applied.
4. Final coat being applied.
