# BELZONA FLANGE REFORM GIVES FIVE YEARS OF LEAK FREE SERVICE

Oil Transfer Hose on FPSO in the North Sea Oil & Gas Industry

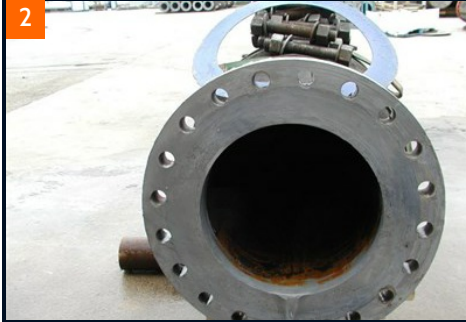
Face formed and pressure tested to 16 Bar

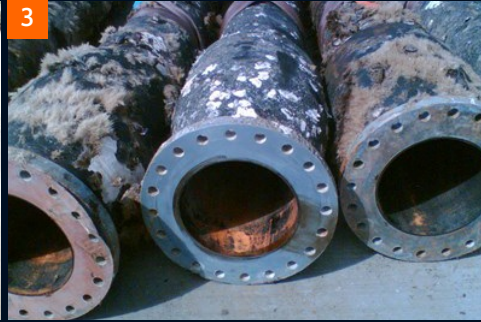
After 5 years service

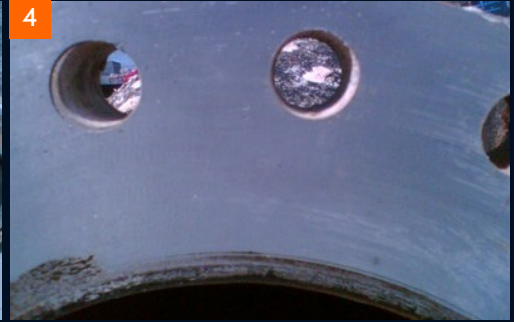
Close up of the reformed face after 5 years service
