# SHAFT REPAIR ON SCREW CONVEYOR

ID: 8933

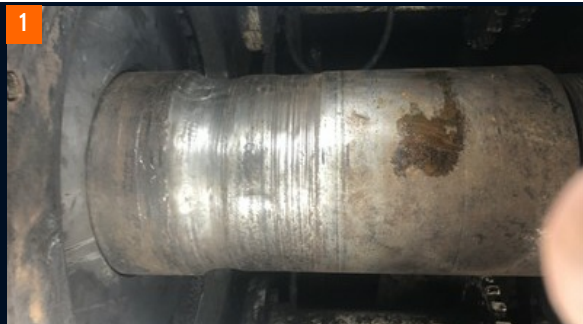
The customer had a bearing failure which resulted in severe metal loss on the shaft.

1. Damaged shaft
2. Surface prep in progress
3. Mold in place and injection of Belzona 1321 Ceramic S Metal complete
4. Completed repair
