# BELZONA STOPS LIVE LEAK

ID: 8937

Leak developed in dissolving tank due to corrosion because of liner failure.

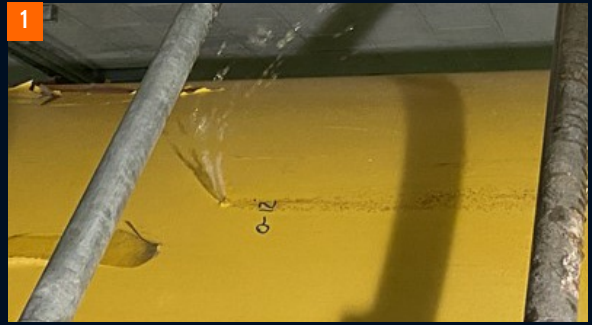
1. Leak as found
2. Surface Preparation completed with MBX
3. Leak stopped with Belzona 9611
4. Area reinforced with Belzona 1212/9341 Mesh
