# BELZONA PROTECTS IRRIGATION CULVERT

ID: 894

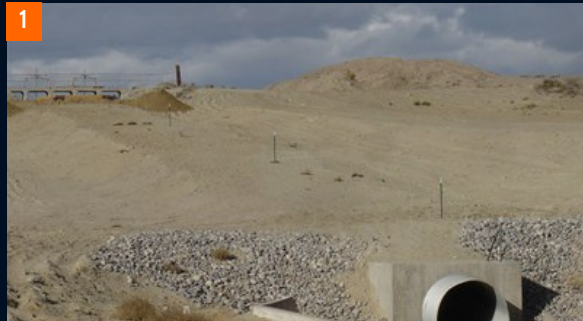
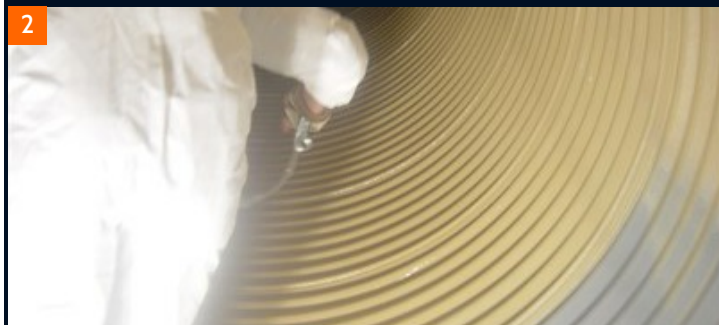
Debris, sand, and silt carried by irrigation water wore through the galvanizing in one season. Left uncorrected, the underlying carbon steel pipe would quickly corrode leading to soil erosion.

1. The galvanized culvert to be protected
2. Belzona 5811 being applied via airless spray
3. The completed application
4. Inspected after one season of operation

Belzona® 5811 and Belzona® 9331 were applied in accordance with a modified Belzona Know-How System Leaflet VPF-2.

Replacement of the damaged pipe would have cost \$700,000 and taken considerable time to complete. The Belzona repair was conducted quickly in situ and saved the customer \$650,000. Inspected after one season and found to be in excellent condition.
