# BELZONA SUPERWRAP 2 SYSTEM REPAIRS STORAGE TANK

ID: 8945

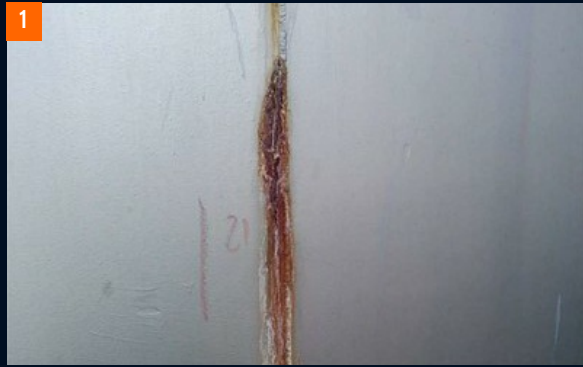
A leak had developed in a storage tank due to corrosion.

1. Leaking area
2. Belzona 1111 & Superwrap 2 applied
3. Completed application

The area was prepared with an MBX Bristle Blaster to SSPC SP11. A cold plate bond was then applied using Belzona 1111. This plate was then encapsulated with Belzona Superwrap 2
