# MUCH DEBRIS FOUND UNDER METAL PLATE OUTSIDE OF OR IN LOCAL HOSPITAL

ID: 8947

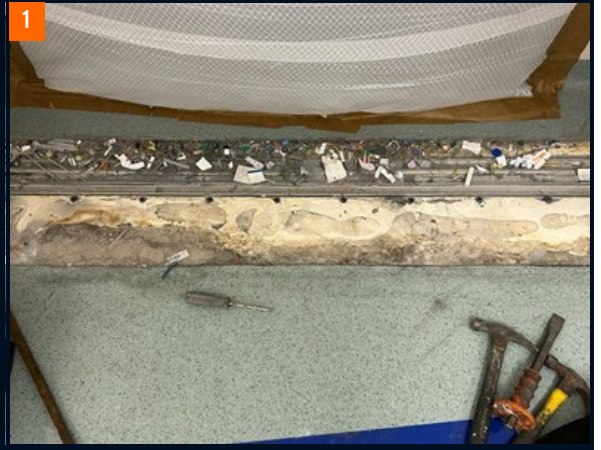
The metal plate covering the expansion joint outside an operating room in a sterile area was trip hazard because the plate was lifting up and separating from the floor. Several employees had tripped and surgical carts toppled from the plate.

1. Removal of plate reveals extensive amount of debris in a sterile area at doorway to operating room.
2. After the plate was removed, the joint was cleaned out and Belzona 4111 was applied to build out the joint nosings.
3. Once Belzona 4111 cured, a thick coating of Belzona 4411 was applied. It was chosen for its fast cure and durability.
4. Last step was to condition the joint area with Belzona 2911 and tape off / fill with Belzona 2211 Elastomer.
