# BELZONA PROTECTS A PICKLING TANK

ID: 8949

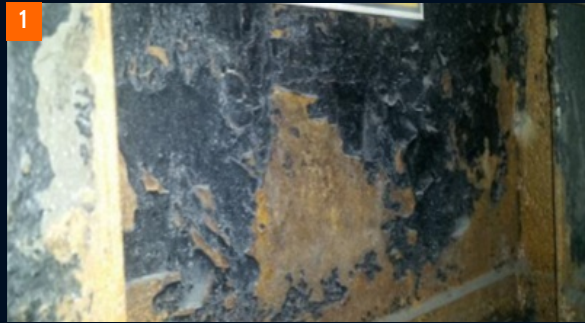
Splashing acid caused deterioration of the metal, which requires protection

1. Original state of the Substrate
2. Image of the damaged area
3. Tank coated
4. Final application photo

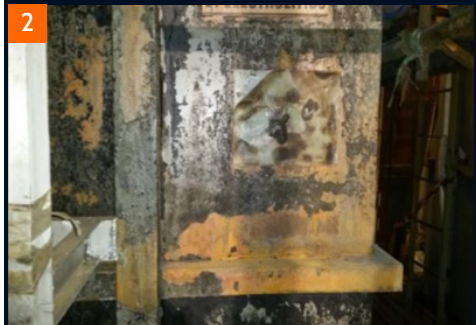
THERE WAS EXTENSIVE DETERIORATION THAT REQUIRED A METHOD OF PROTECTION FROM FURTHER ATTACK, BELZONA MATERIAL WAS ABLE TO BE USED TO PROVIDE THIS PROTECTION

1- THE APPLICATION WAS CARRIED OUT ON SITE. FIRST THEY PREPARED THE SURFACE BY GRINDER REMOVING ALL THE PREVIOUS COATING.

2-THE METAL IS THOROUGHLY CLEANED AND RECHARGED IN THE WORN AREAS
