# BELZONA SEALS LEAK IN OIL STORAGE TANK

Oil storage tank

Power Station, Ravenna, Italy

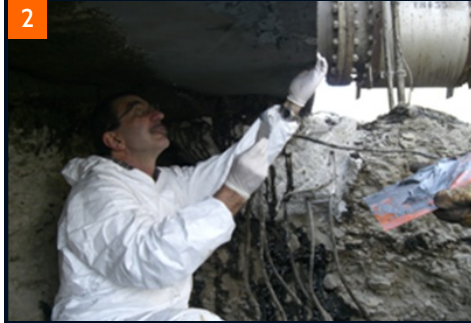
Corrosion of the metal flooring caused a severe leakage of oil into the environment. Welding was not possible.

1. View of the leakage after the area was blasted
2. Belzona 1161 being applied
3. Belzona 1111 applied on the metal plate
4. Positioning and fixing the metal plate with clamps and adjustable risers

Application was carried out in accordance with Belzona Know How System Leaflet TCC-1. Area under the leak excavated before doubler plates could be bonded and supported in position with adjustable jacks.
