# BELZONA SEALS THE GAP

ID: 8950

## PROBLEM

ANTI-ACID TILE FLOOR FAILURE CAUSES DAMAGE AND LIFTING OF TILES, DUE TO THE RECURRING FAILURE IN THE JOINTS BETWEEN TILES.

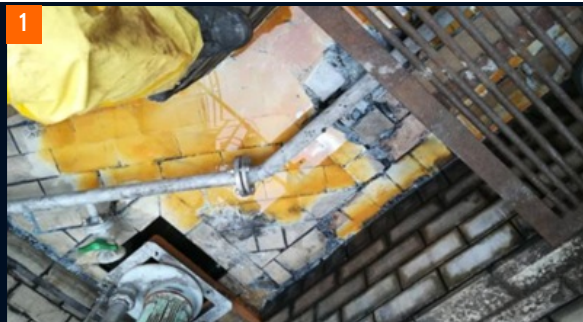
1. INITIAL CONDITION
2. SURFACE PREPERATION
3. APPLICATION COMPLETED
