# RECYCLED ACID CONTAINMENT CONCRETE REPAIR & COATING

ID: 8951

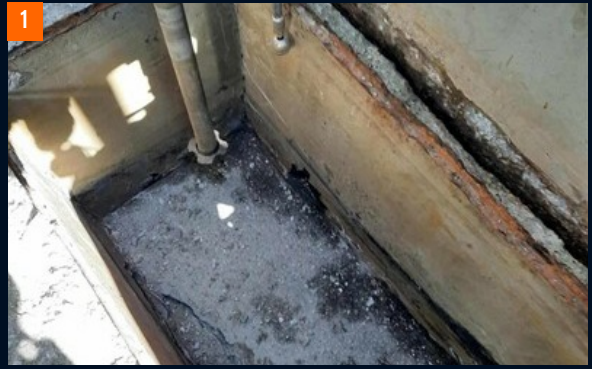
A rubber lined recycled acid day tank occurred a leak in a seam in the liner and exposed the containment to acid. The acid filled the secondary containment almost 2 foot deep and destroyed the previous coating. Over time and years of exposure during filling the small amounts that leaked from the flange and hose caused the damage to the sump pit area.

1. Damage to the sump pit area.
2. Repairs that were made using Belzona 4111.
3. Finished repair and coating. Belzona 4311 was used.
