# BELZONA REPAIRS SPRINKLER TANK

ID: 8952

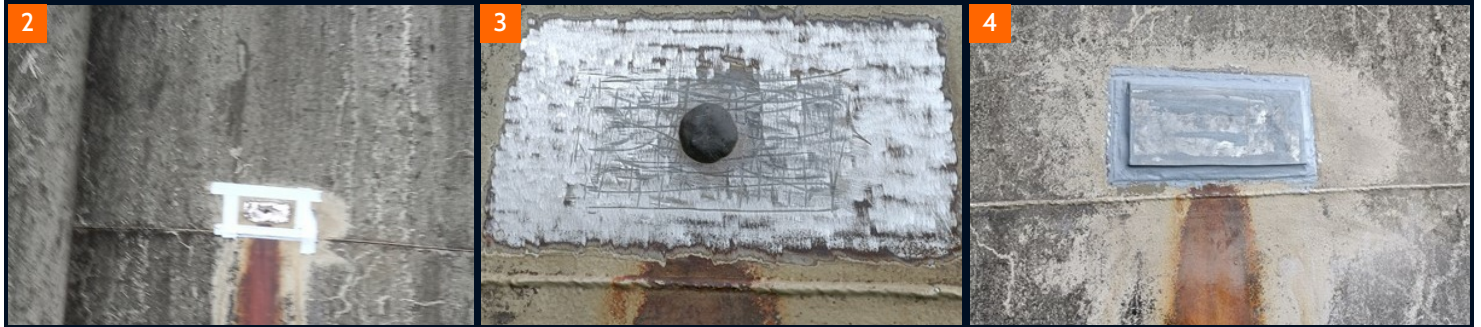
A pinhole leak had developed on the side of a sprinkler tank

1. Leak on tank
2. Initial surface preparation
3. Leak sealed with Belzona 9611 & additional surface preparation carried out
4. Plate bonded in place with Belzona 1161

The initial area was first prepared back to bare metal & the leak was sealed with Belzona 9611. Once this was done the larger area was prepared using an angle grinder. A plate was then bonded in place using Belzona 1161 UW Metal
