# LUXURY YACHT P FRAMES PROTECTED FROM CAVITATION WITH BELZONA 2141

ID: 897

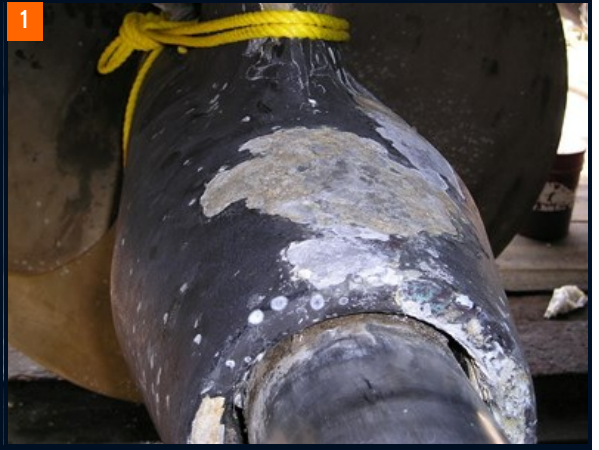
Cavitation had caused erosion of the parent metal and threatened the structural strength of the component if left untreated.

1. Original condition of component
2. Close up of cavitation damage
3. Belzona 2141 mid application
4. Belzona 2141 after 12 months (overcoated with antifouling)

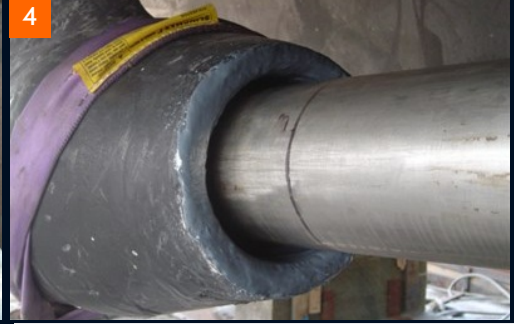
Inspection of the Belzona® 2141 system after 12 months service in this aggressive environment showed no attack to the Belzona coating.
