# CHEMICAL FLOOR DRAINS

ID: 8994

Chemical & Petrochemical

Loughborough

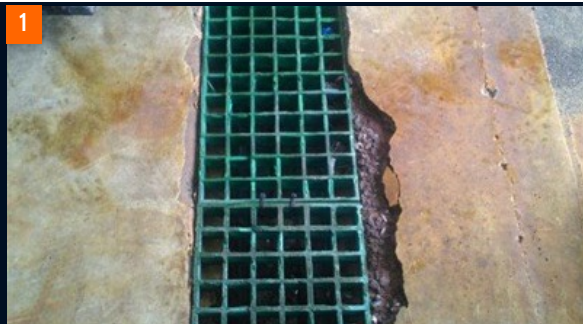
A network of floor drains had found to be compromised by age, wear and harsh chemical attack. The chemicals included were Sulphuric, Hydrochloric, Nitric, Methanol and Acetone, amongst a cocktail of others. Percentages varied, but could reach as high as 50%, though only on very rare occasions.

1. Loose grates and crack shoulders, requiring rebuilding using 4181
2. Work ongoing
3. Completed 4181 concrete repairs and 4331 coating
4. Completed 4181 concrete repairs and 4331 coating

Carry out surface preparation to the required standard, removing surface contamination and loose concrete/repair material.

Mix and apply Belzona® 4911 surface conditioner to areas within drain channel for repair.

Mix and apply Belzona® 4181 to drain channel profile. This will be done by trowel but may also be aided with form work.
