# COAL SILO FLOPGATE

ID: 8998

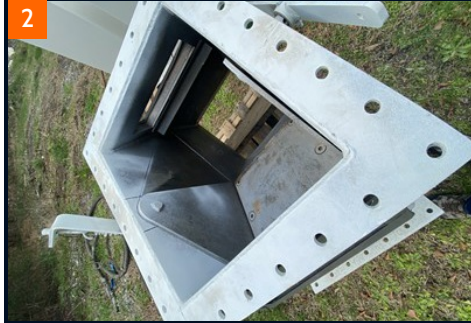
1. New chute pre-coating
2. New Flopgate pre-coating
3. New chute coated with Belzona Ceramic Carbide FP (1812)
4. New flop gate coated with Belzona Ceramic Carbide FP (1812)

Chutes and flop gate value were abrasion blasted. Blasted area was then cleaned using Belzona 9111. Belzona 1812 was applied using an applicator at 1/4" thickness.
