# PROTECTING A PIPE SPOOL

ID: 8999

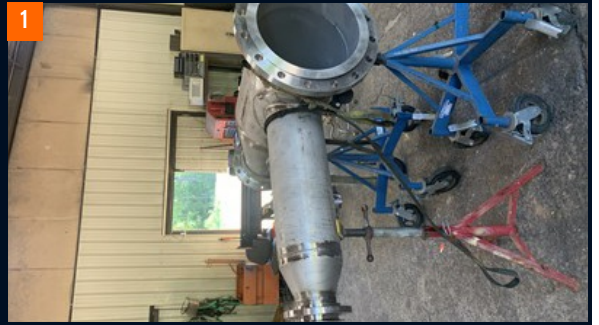
1. Pipe spool with interior pipes blasted to attain proper surface preparation.
2. Interior of pipe spool with Belzona 4301 applied.
3. Different view of the interior of the pipe spool after applying Belzona 4301.
4. Finished product curing in the South Carolina August Sun.

After blasting, we applied Belzona 4301 using brushes. It was tricky in some of the smaller pipe areas of the spool, but we were able to get a good application on the entire internal pipe spool. We inspected the areas thoroughly after the application.
