# BELZONA PROTECTS FAST FERRY BOW THRUSTERS FROM CAVITATION

ID: 900

Bow Thrusters from a 900 Passenger High Speed Service Ferry capable of 38 knots.

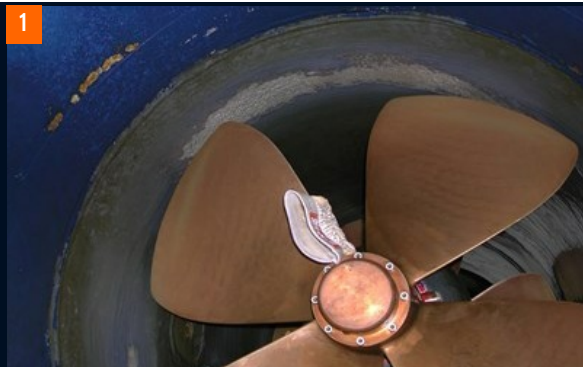
Cavitation problems had manifested themselves in the Port and Starboard Bow Thruster Tunnels. Annual repairs had been attempted with glass flake coatings and Belzona® 1341, but none had been ideal allowing metal loss to continue in the tunnel.

Localized damage to Belzona 1341 (Port)  
Extensive damage to Glass Flake lining (Starboard) Belzona 2141 (Portside)  
Inspection after 5 years service

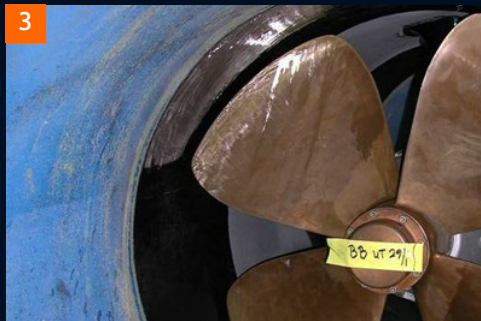
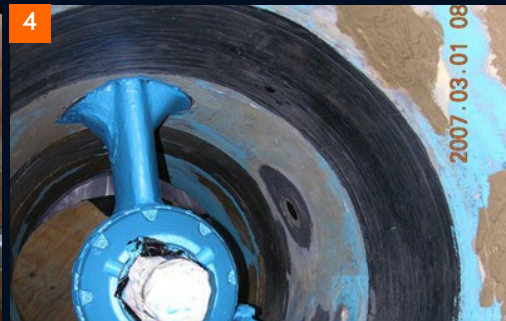
Subsequent annual inspections have shown the Belzona® 2141 to provide outstanding cavitation protection. After nine (9) years in service the Belzona 2141 remains in excellent condition apart from a few mm<sup>2</sup> of mechanical damage. The client is extremely pleased with the application which has allowed them to extend the annual docking cycle to a bi-annual one

Following removal of the existing coatings Belzona® 2141 was applied in accordance with a modified version of SOS-1 and SOS-2.
