# BELZONA LINING FOR INTERNAL PROTECTION OF HYDROCYCLONE TANK

ID: 9005

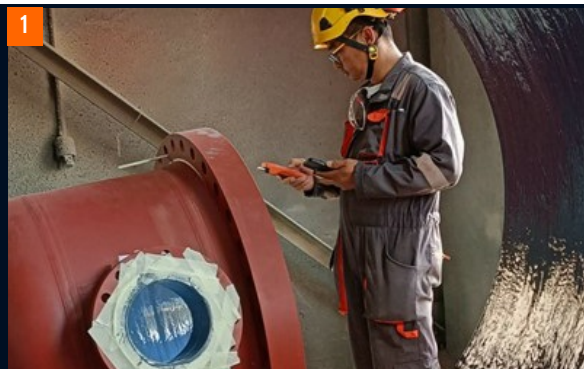
The existing ceramic lining of the hydrocyclone vessel showed visible signs of damages, such as blisters and cracks. Normal coatings are not suitable for use in these conditions due to the harsh chemicals and operating conditions.

1. Overall internal surfaces coated with Belzona 1391.
2. Belzona 1391 brush applied in a nozzle.
3. Belzona 1391 brush applied in a nozzle.
4. Inspection with a wet sponge tester for holiday detection.

Prior to coating application, the surface of the vessel was blasted to Sa 2.5 Near White Metal and all parameters were tested to ensure that the surface was suitable to be coated. The application of Belzona 1391 to the vessel was carried out manually at an average thickness of 500 microns, following the guidelines described in the Belzona 1391 Instructions for Use.
