# RUBBER LINING ON LIMESTONE FILTER TANK REPLACED WITH BELZONA'S EPOXY LINING

ID: 9006

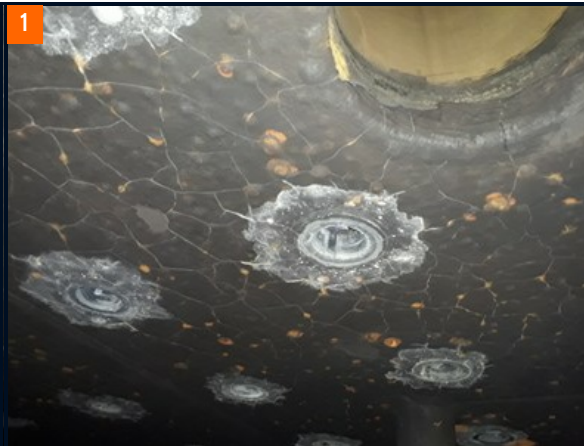
Cracks, blisters, delaminations and alligatoring were found in the existing rubber lining of the tank after a long period of use without maintenance.

1. Cracking on the original rubber lining
2. Delaminations on the original rubber lining
3. Initial coat of Belzona 1321 being applied
4. Application completed and protected tank inner surfaces

Damaged areas of the existing rubber lining were removed and the exposed metal surface was grit blasted. Exposed deeply pitted areas were filled with Belzona 1111 and rebuilt up to 1 mm to compensate for metal loss. Multiple coats of Belzona 1321 were applied by brush for extra protection.
