# IN-SITU REPAIR OF CRACKS IN BUS FUEL TANK

ID: 9007

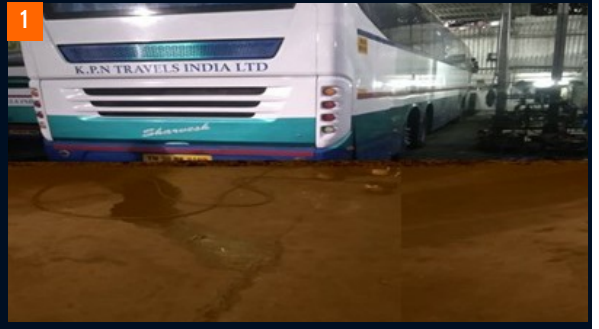
A bus diesel tank was cracked and leaking.

1. Bus with fuel tank leakage problems
2. Cracked and leaking fuel tank
3. Fuel tank that has been repaired and is no longer leaking
