# EXTERNAL COATING FOR AIRPORT JET FUEL PIPELINE

ID: 9008

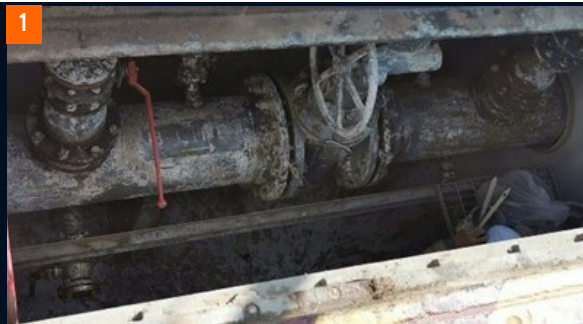
The facility manager responsible for the airport's infrastructure found problems related to the jet fuel pipeline. Corrosion has been detected, posing a significant risk to the safety and reliability of the pipeline.

1. Original condition of the corroded pipeline
2. Application in progress
3. Application completed
4. Pipeline fully coated for corrosion protection

The application was carried out in accordance with Belzona Know-How System Leaflet VPF-2 and two coats of Belzona 5831 was applied. As hot work was prohibited, manual surface preparation was carried out. No damage was caused by this process.
