# BELZONA REPAIRS VESSEL SKEG

ID: 9009

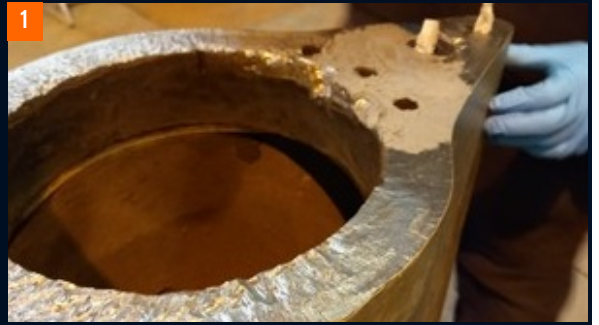
Erosion & corrosion had taken its toll on a marine skag. There was significant metal loss in need of repair before the part could go back into service

1. Surface preparation carried out & Belzona 1111 applied
2. Belzona 1111 built up over the full surface
3. Close up of inner edge forming
4. The repair area machined back down to the required dimensions

The corroded areas were prepared using grinding tools to get back to bare metal & to roughen the surface. Belzona 1111 was then applied ~2mm proud of the surface. Applicator tools were used to form the inner bearing surface. Once the Belzona 1111 had reached its initially cure stage it was machined back down to the original equipment dimensions.
