# BELZONA 2141 PROTECTS FRANCIS TURBINE RUNNERS FROM CAVITATION

ID: 901

Twin 914mm (36 inch) Francis Turbine Runners operating with 13m (42 feet) head and constructed in 1945.

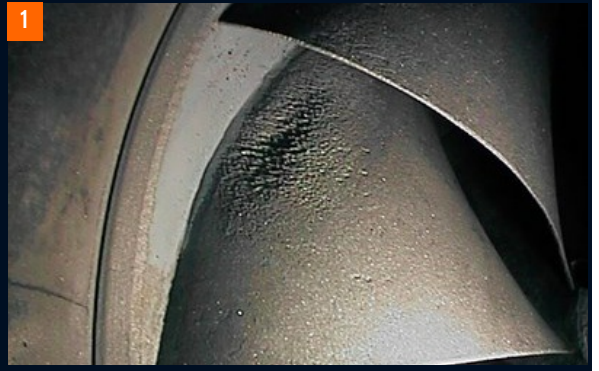
Cavitation had caused erosion of the parent metal and loss of performance of the turbine. Belzona® 1341 and Belzona® 1421 had been applied in 1998 but had suffered erosion in this aggressive environment.

1. Cavitation damage
2. Belzona 1341 (left) and Belzona 1421 (right) after 36 months service
3. Belzona 2141 after application
4. Belzona 2141 after 34 months

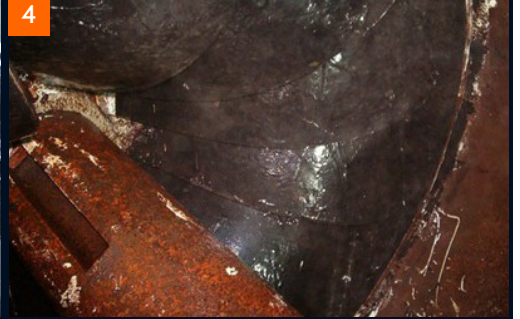
Inspection of the Belzona® 2141 in 2002 showed no damage – further inspection after 34 months showed no sign of damage to the coating.
